Situation Photo Log

Tuesday, October 23, 2012

Kalamazoo River / Enbridge Spill

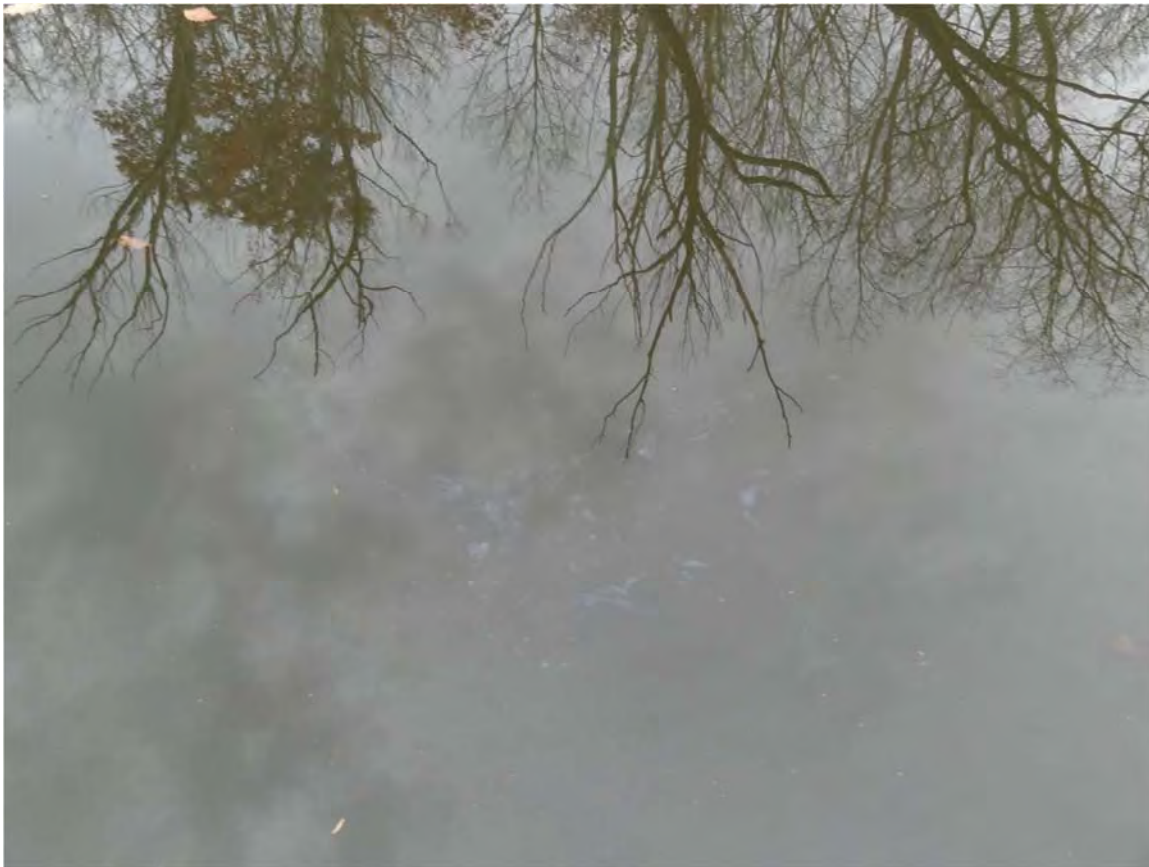
47. Morrow Lake North Cove sheen and tar globs observed.

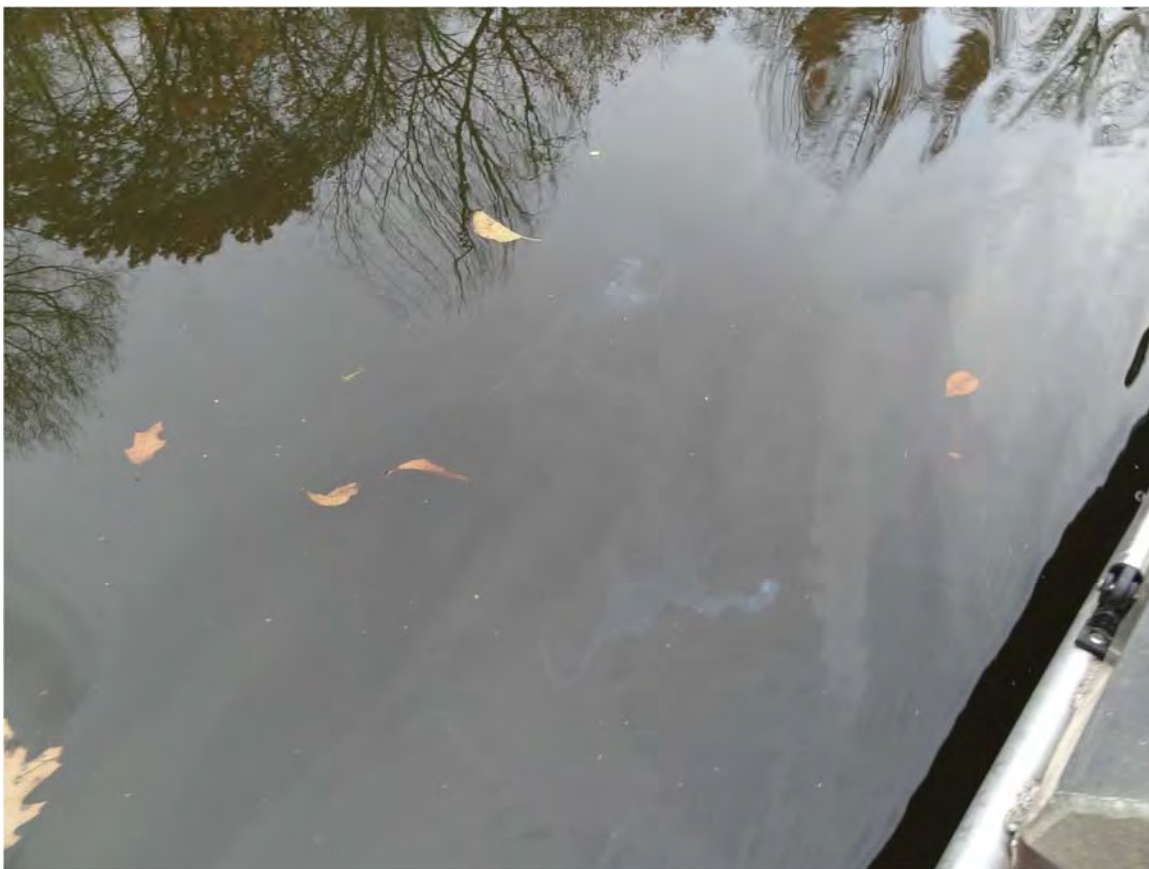
48. Morrow Lake North Cove sheen and tar globs observed.

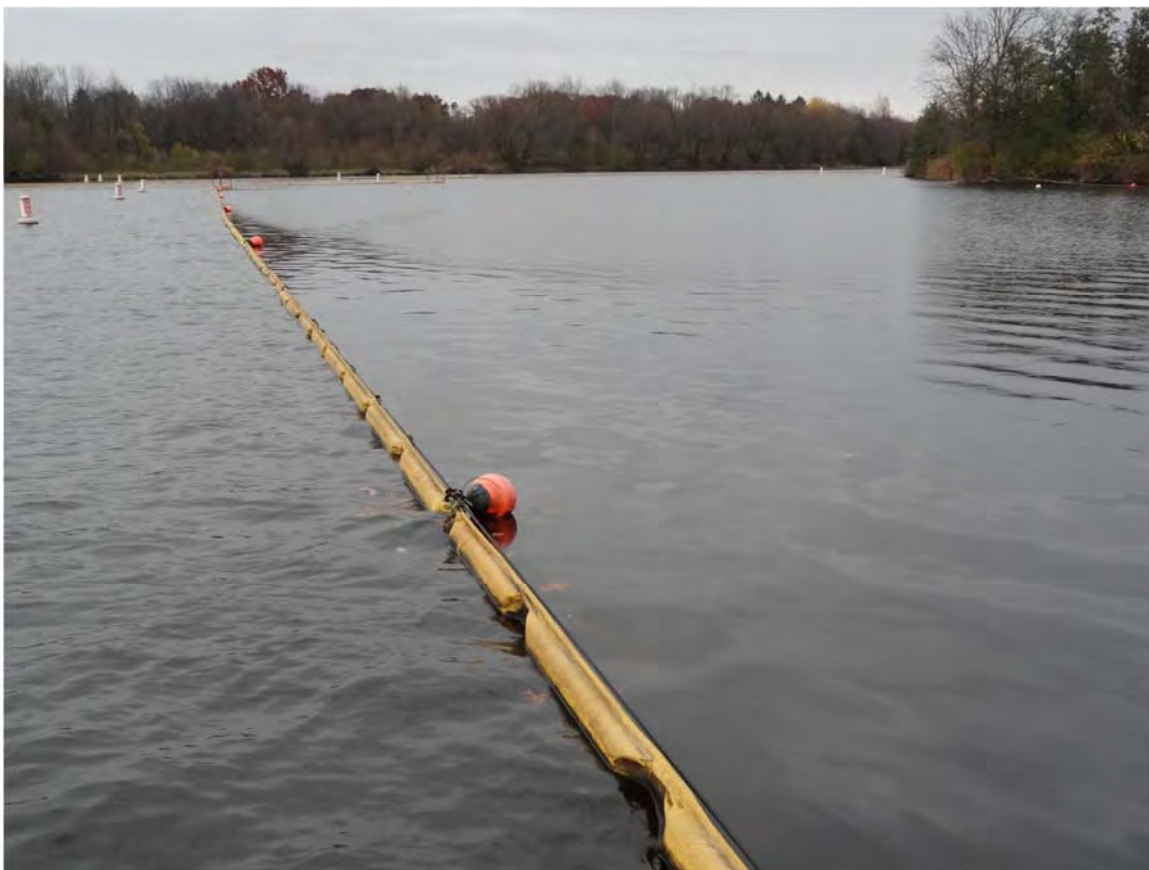
49. Morrow Lake Delta Gate F south sheen and tar globs observed.

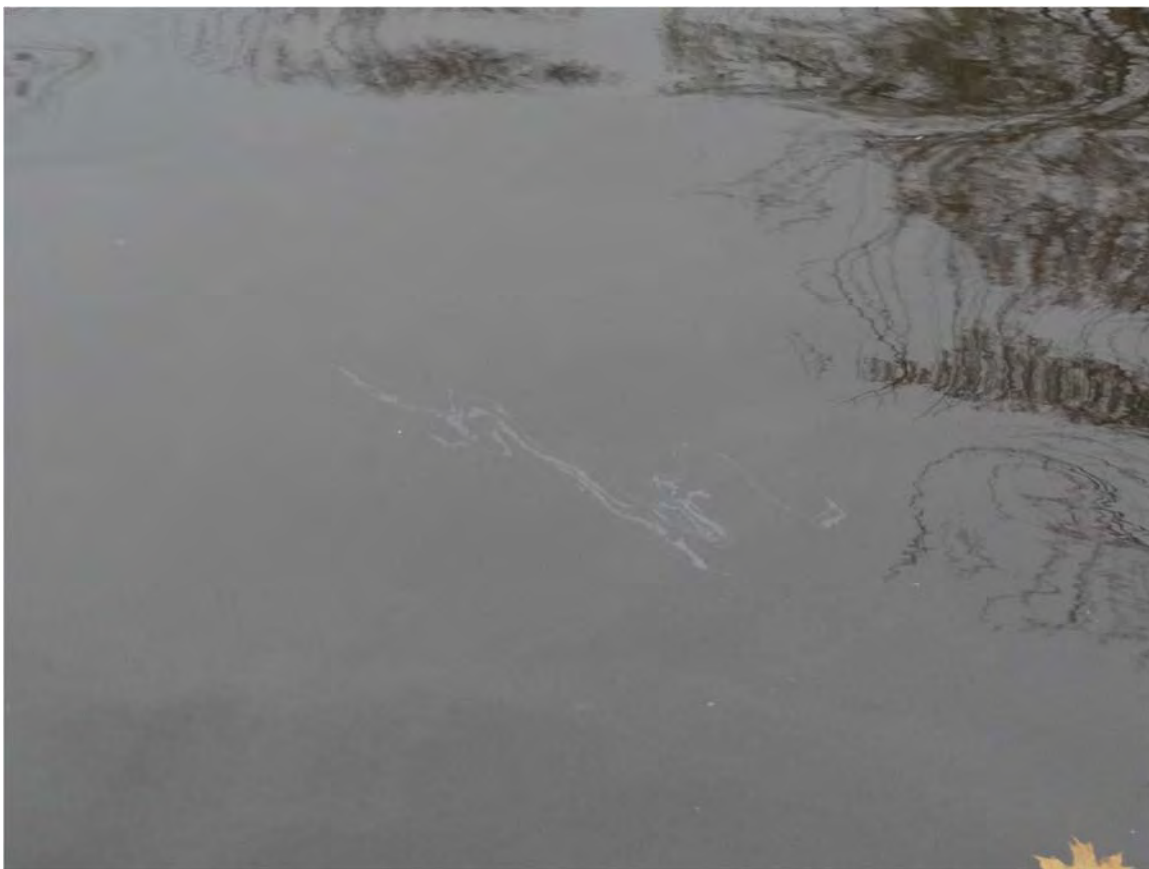
50. Morrow Lake Delta Gate F south sheen and tar globs observed.

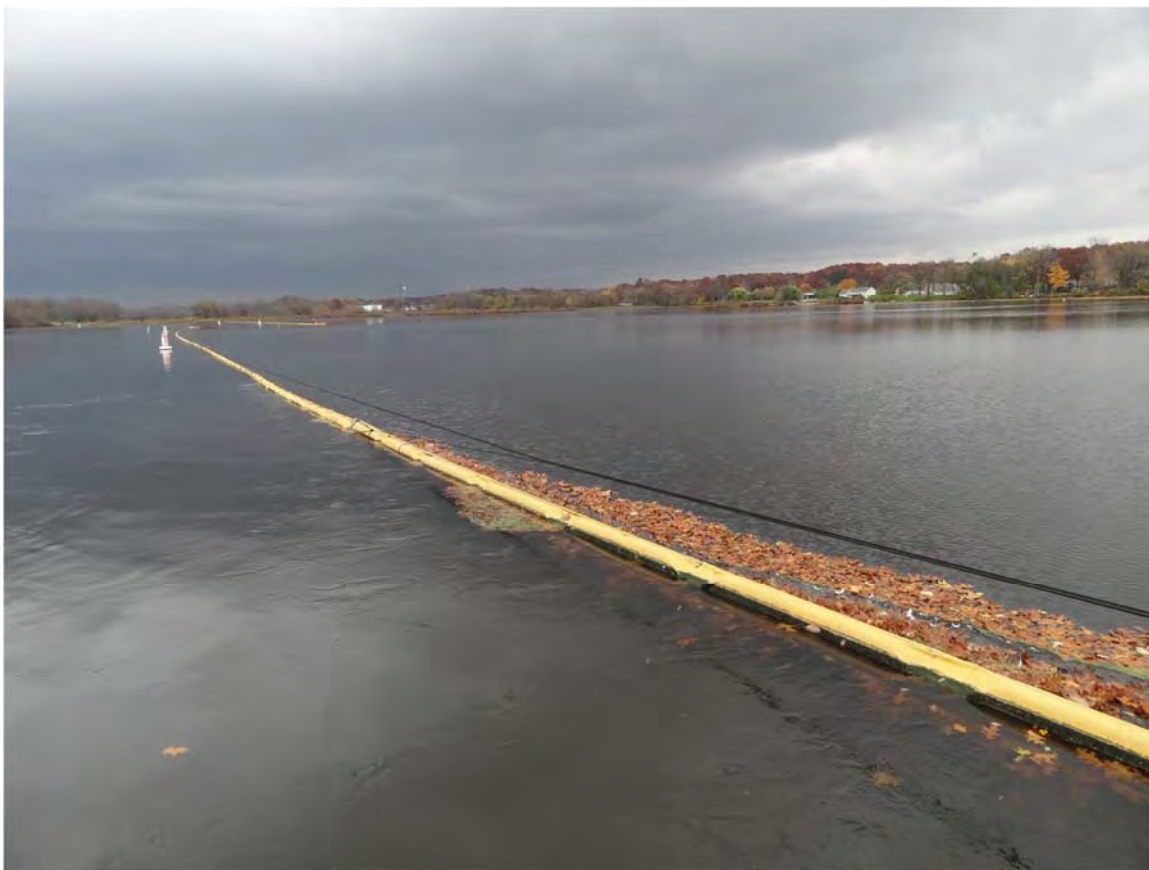
51. Morrow Lake Delta Gate C sheen and tar globs observed.

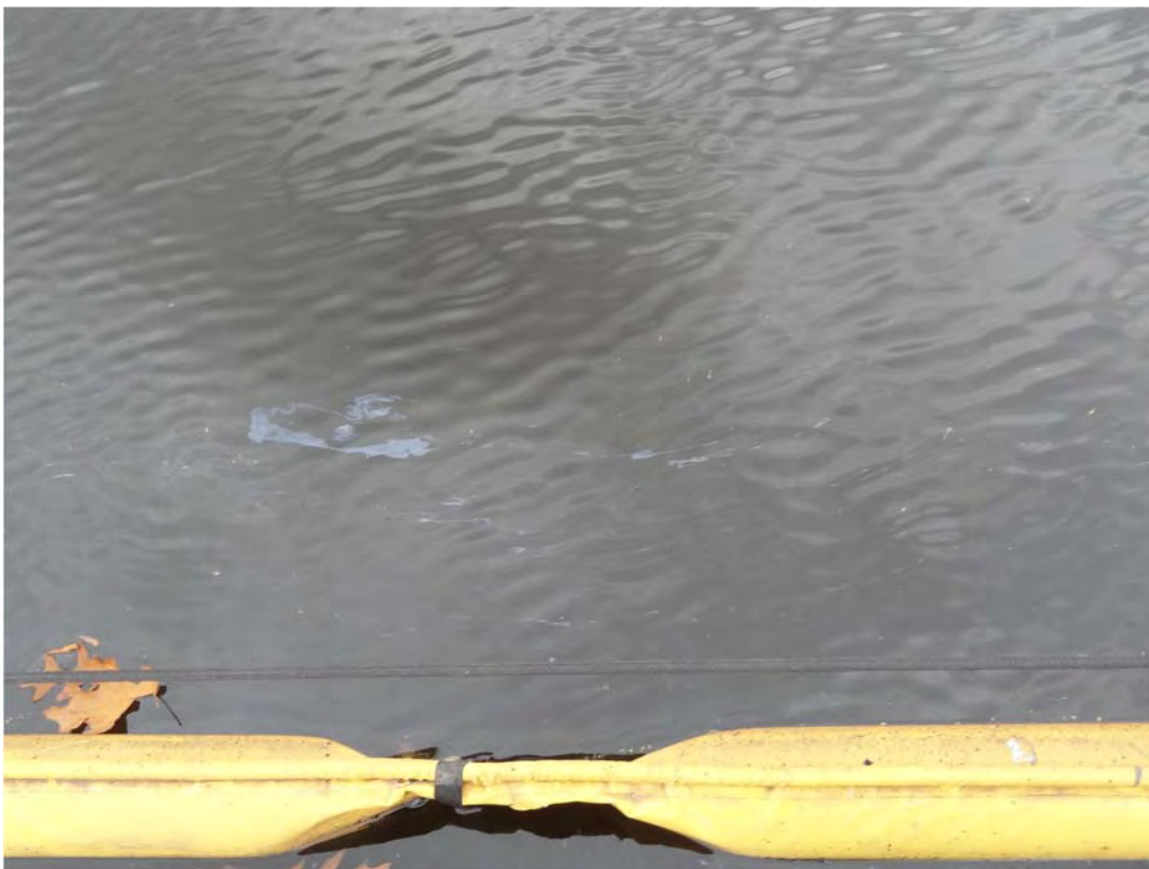
52. Morrow Lake Delta Gate C sheen and tar globs observed.

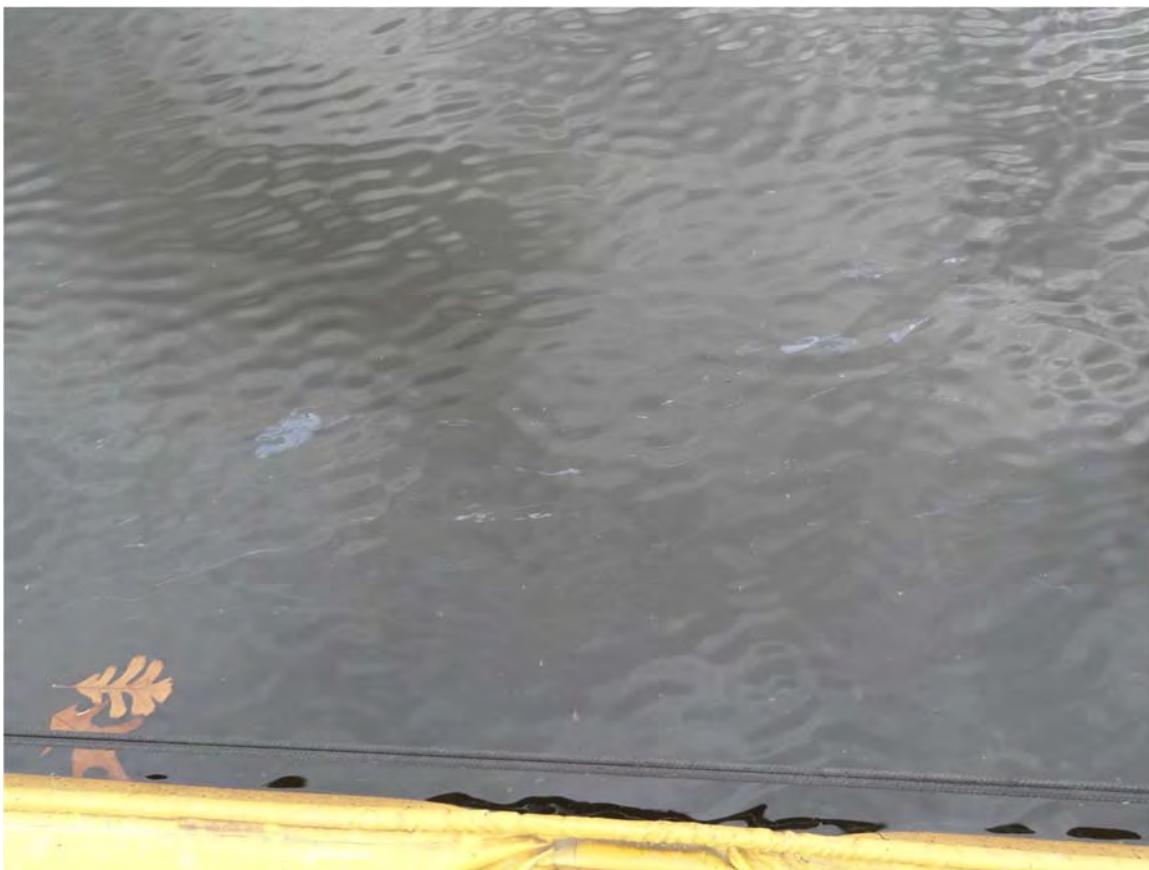
53. Morrow Lake Delta Gate C sheen and tar globs observed.

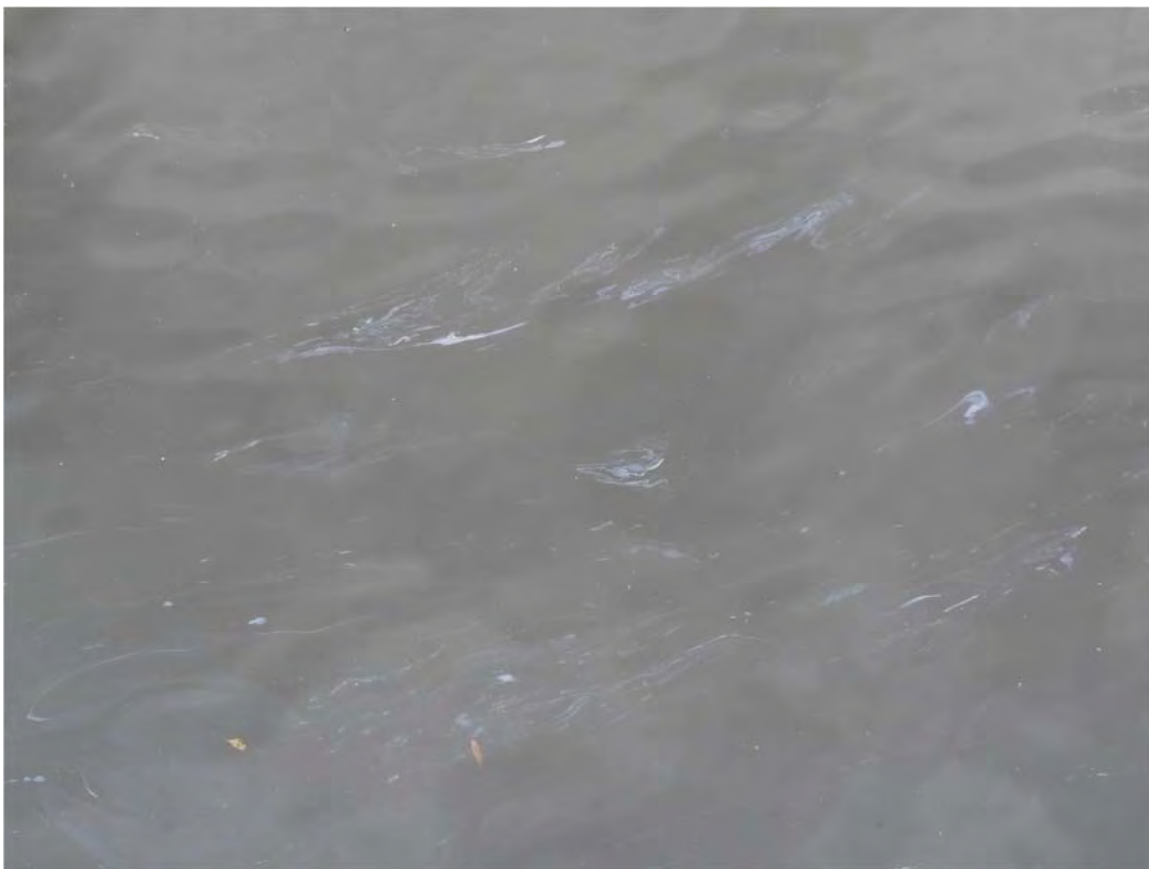
54. Morrow Lake Delta Gate C sheen and tar globs observed.

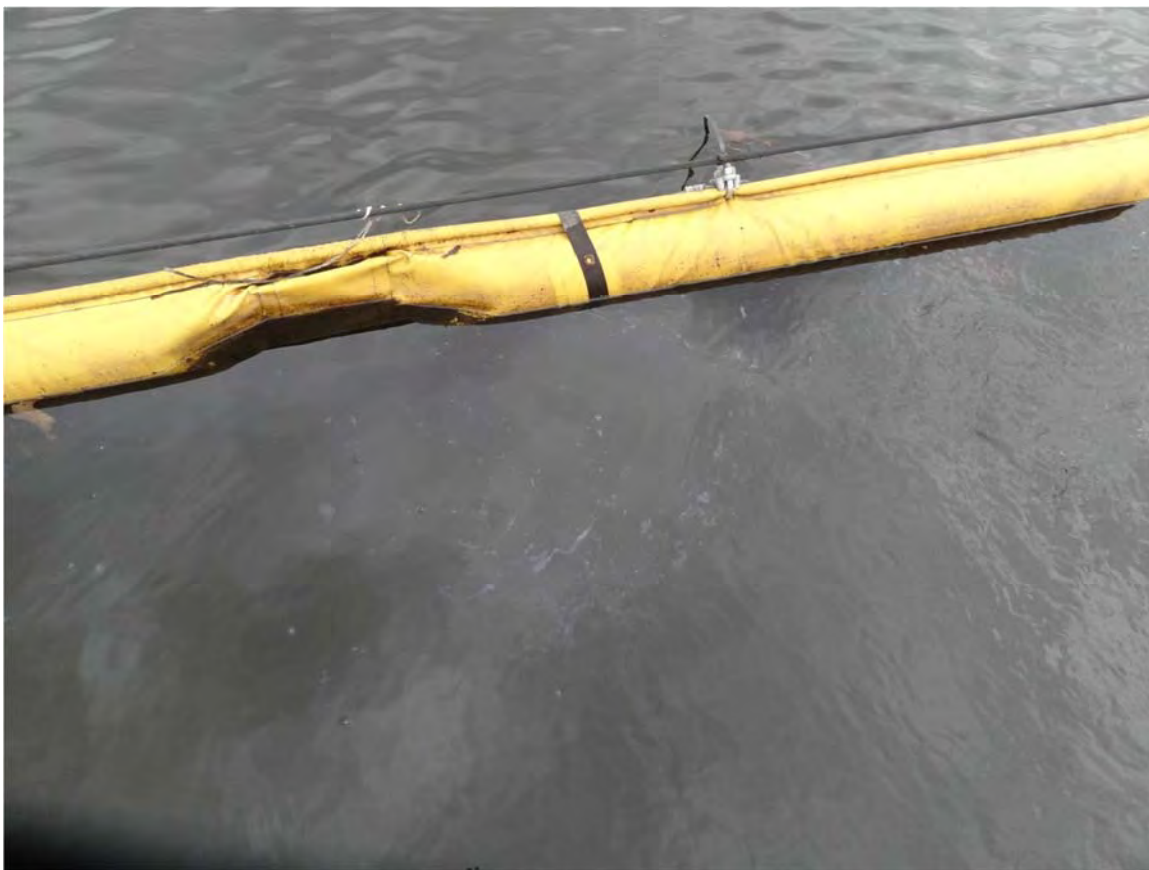
55. Morrow Lake Delta Gate C sheen and tar globs were observed collecting along the downstream side of the boom.

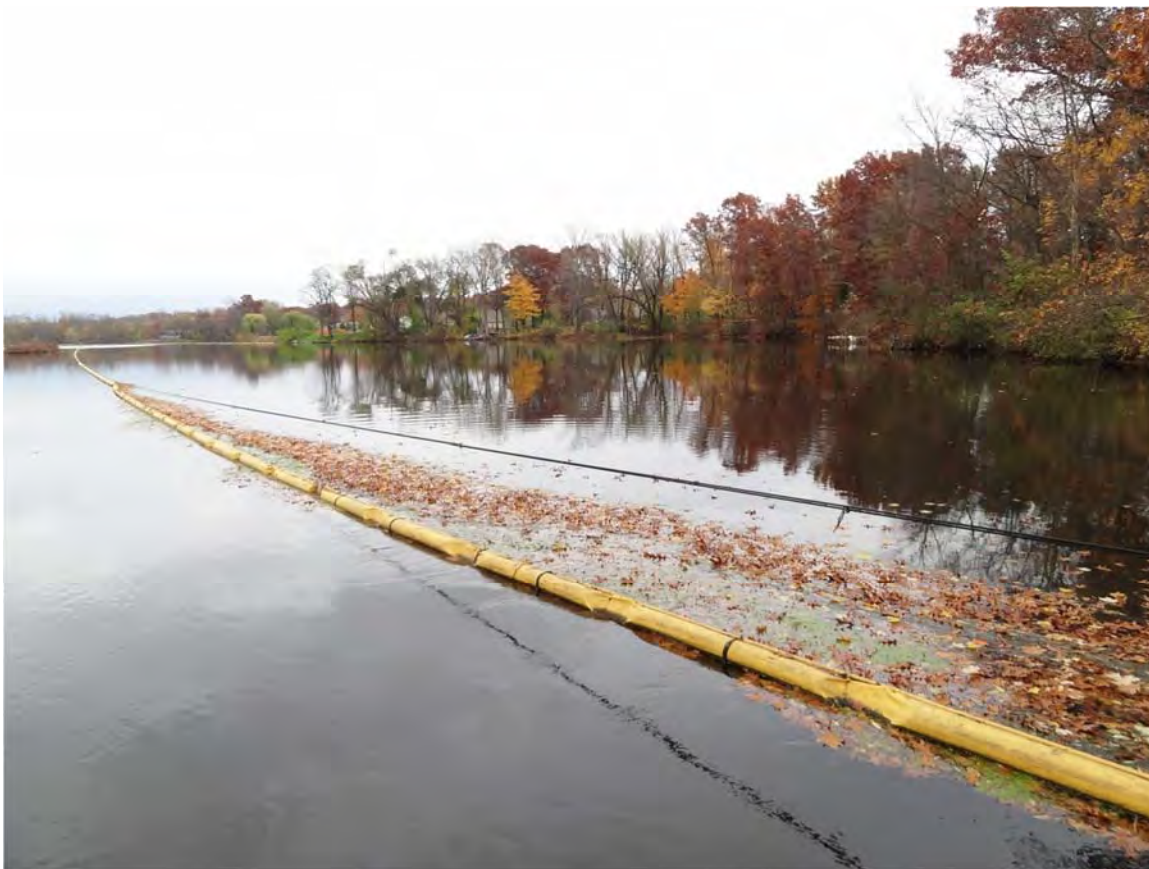
56. Morrow Lake Delta Gate B sheen and tar globs observed.

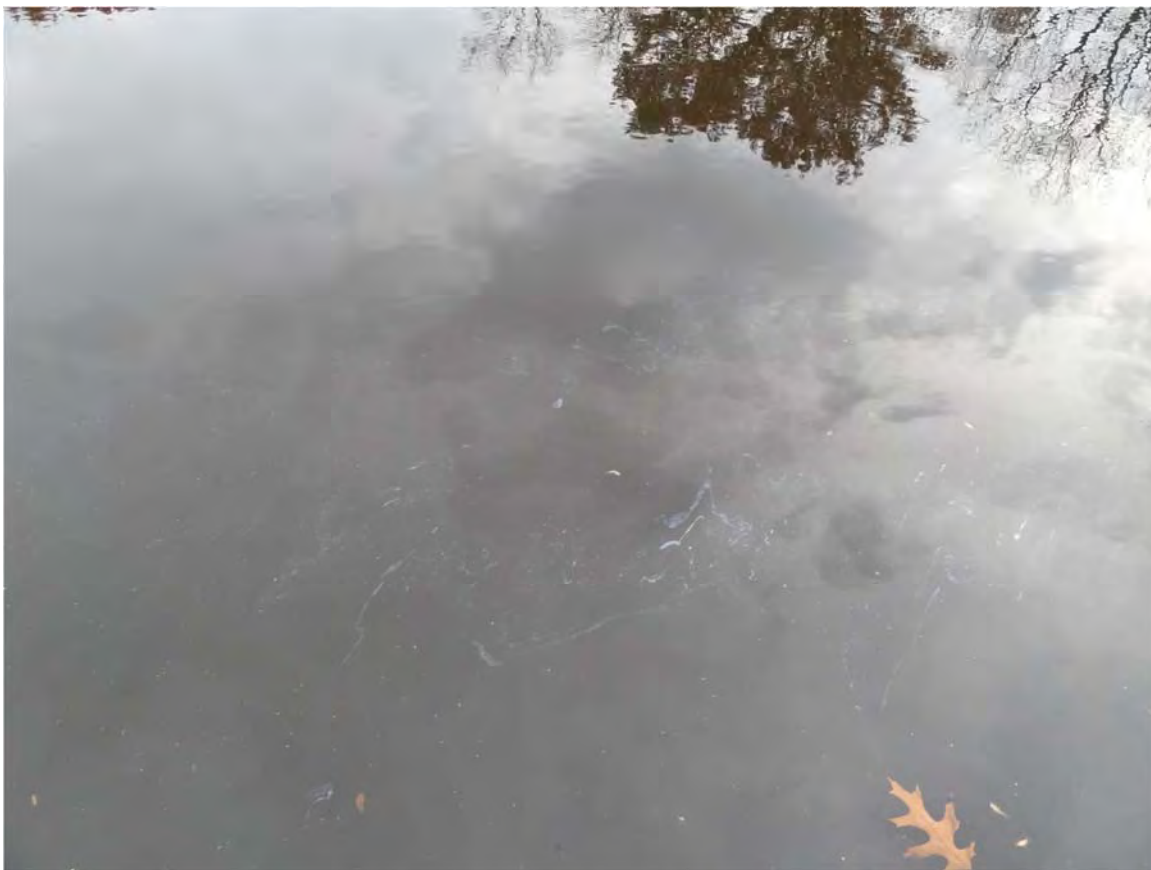
57. Morrow Lake Delta Gate B sheen and tar globs observed.

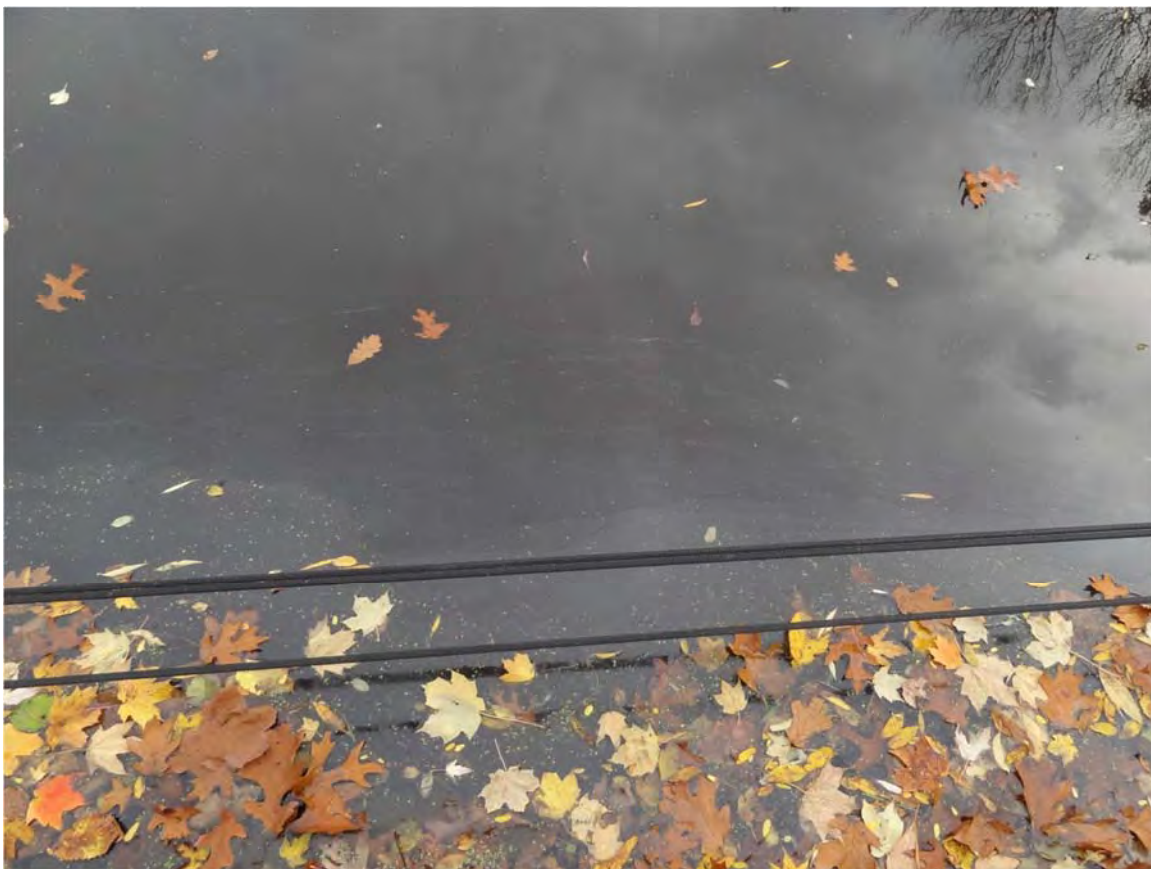
58. Morrow Lake Delta Gate B sheen and tar globs observed.
